# Manhole Inspection Summary

Manhole # S31M\_\_011MH

Insp Date: **12/26/08 10:19 AM**

**Location** Address: **652 W Conway St**

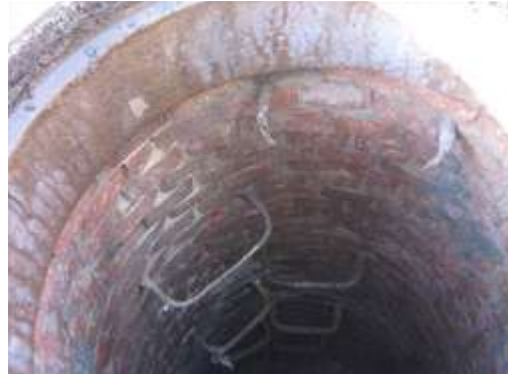
Defect 5

Condition: ☐ Sound ☐ Cracked ☒ **Leaks**

frame infiltration at lid, steps corroded, step missing

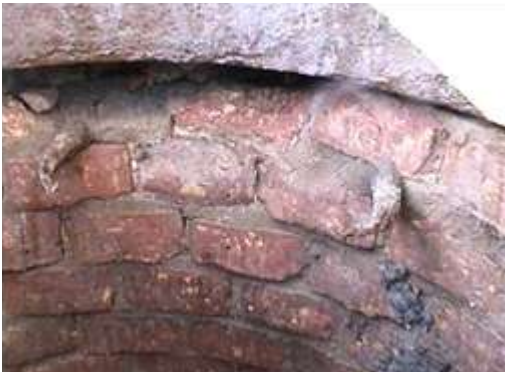
Defect 4

Condition: ☐ Sound ☒ **Cracked** ☐ Root Intrusion ☐ Loose Brick ☒ **Deteriorated**

chimney cracked bricks and deteriorated

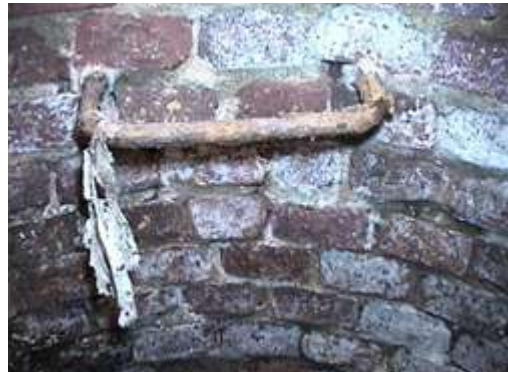
Defect 3

Count: **8** Missing: **1** ☒ **Corroded**

☒ **Evidence Of Surcharge** Depth: **4** (ft.) ☐ Active Surcharge Present

steps corroded, signs of surcharge 4 feet

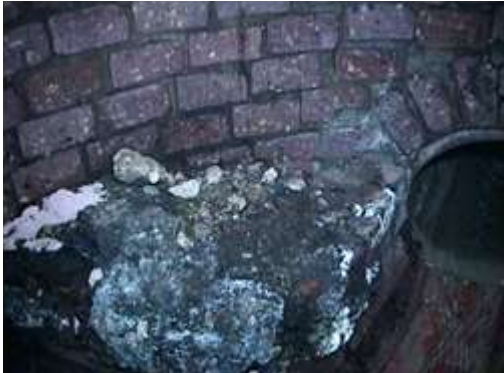
Defect 2

Condition: ☐ Sound ☐ Cracked ☐ Root Intrusion ☐ Deteriorated ☐ Leaks ☒ **Debris**

bench debris

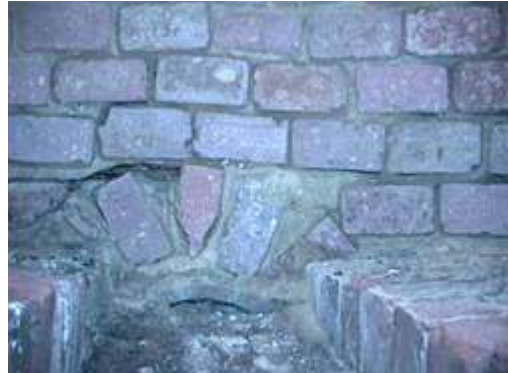
Defect 1

Condition: ☐ Sound ☒ **Cracked** ☐ Root Intrusion ☐ Loose Brick ☐ Deteriorated

Condition: ☐ Sound ☐ Cracked ☐ Root Intrusion ☐ Deteriorated ☐ Leaks ☒ **Debris**

barrel missing mortar near Drop In @ 6  
OClock, channel debris

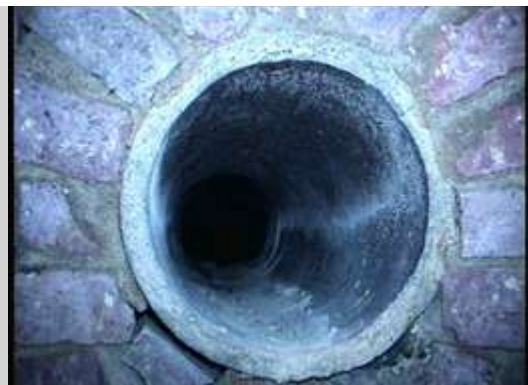
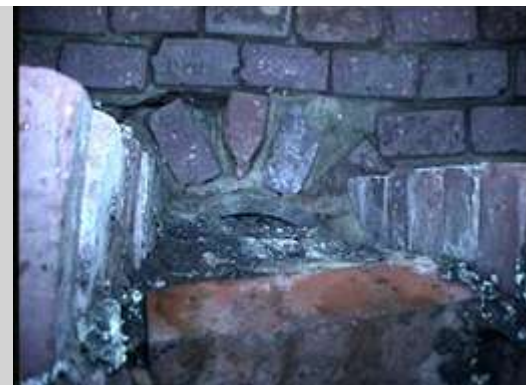
Drop In @ 6 OClock

drop extension bricked-up

Infiltration: **None** Pipe Seal Cond: **Cracked**
